Technical Information

Air Conditioner

CS-E9BKP
CS-E12BKP
CS-E9CKP
CS-E12CKP

Subject : Fan Motor Ball Bearing Noise

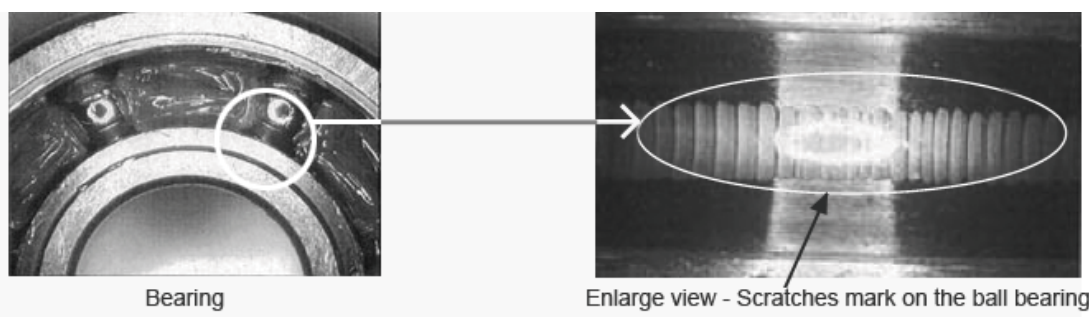
Electro-Chemical Corosion occurs that current flows periodical through ball bearing and creates sparks (wave like abrasion) to the surface.

The defective bearing (at longer shaft side) found a wave line scratch patterns on the bearing wheel surface.

Occurance of electro-chemical corosion is improved after implementation on the remedy parts. Remedy parts of new source and HMM fan motor double washer will provide a better leakage current protection.
